GREAT NEAPOLITAN EARTHQUAKE OF 1857.

OBSERVATIONAL SEISMOLOGY

TO INVESTIGATE THE CIRCUMSTANCES OF THE GREAT
EARTHQUAKE OF DECEMBER 1857.

ROBERT MALLET, C.E., F.R.S., F.G.S., M.R.I.A.,
&c., &c.

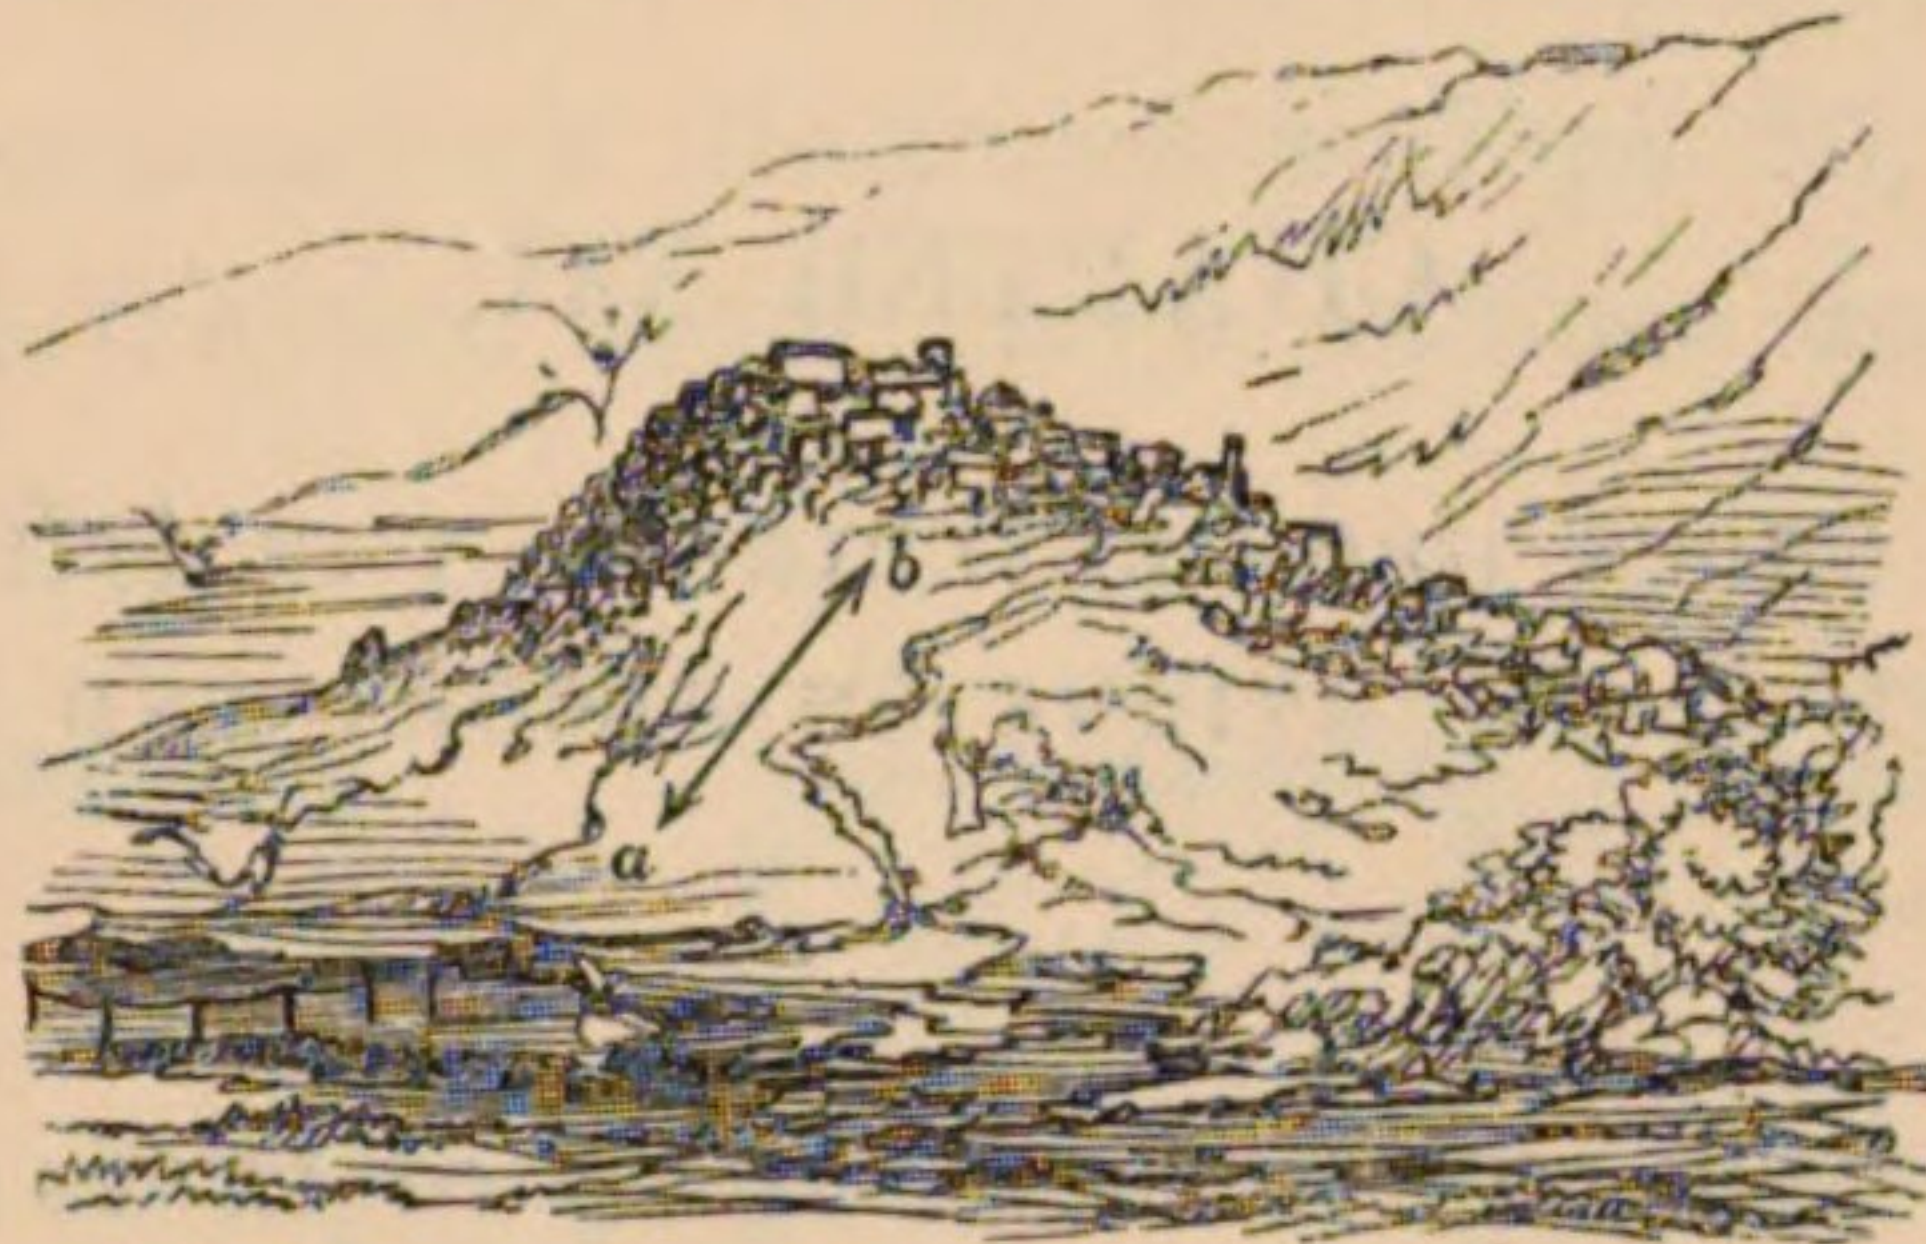
Fig. 69.

If in place of the town standing upon pretty level ground, as previously assumed, it stand upon a hill summit, and on its flanks, the difference of devastation, at different sides, is usually great. If, as in Fig. 69, the shock emerge in the direction $a-b$, the buildings at the right and left, are differently affected, because their grasp upon the ground at their foundations is different, the relative direction of emergence different (as will be more fully examined when

treating of the relations of geological formation to shock), and often (as at Saponara) chiefly because the houses that fall at the steep side to the left hand, fall against and upon,

those below them, and the accumulated ruin falls in an avalanche of rubbish down the hill-side.

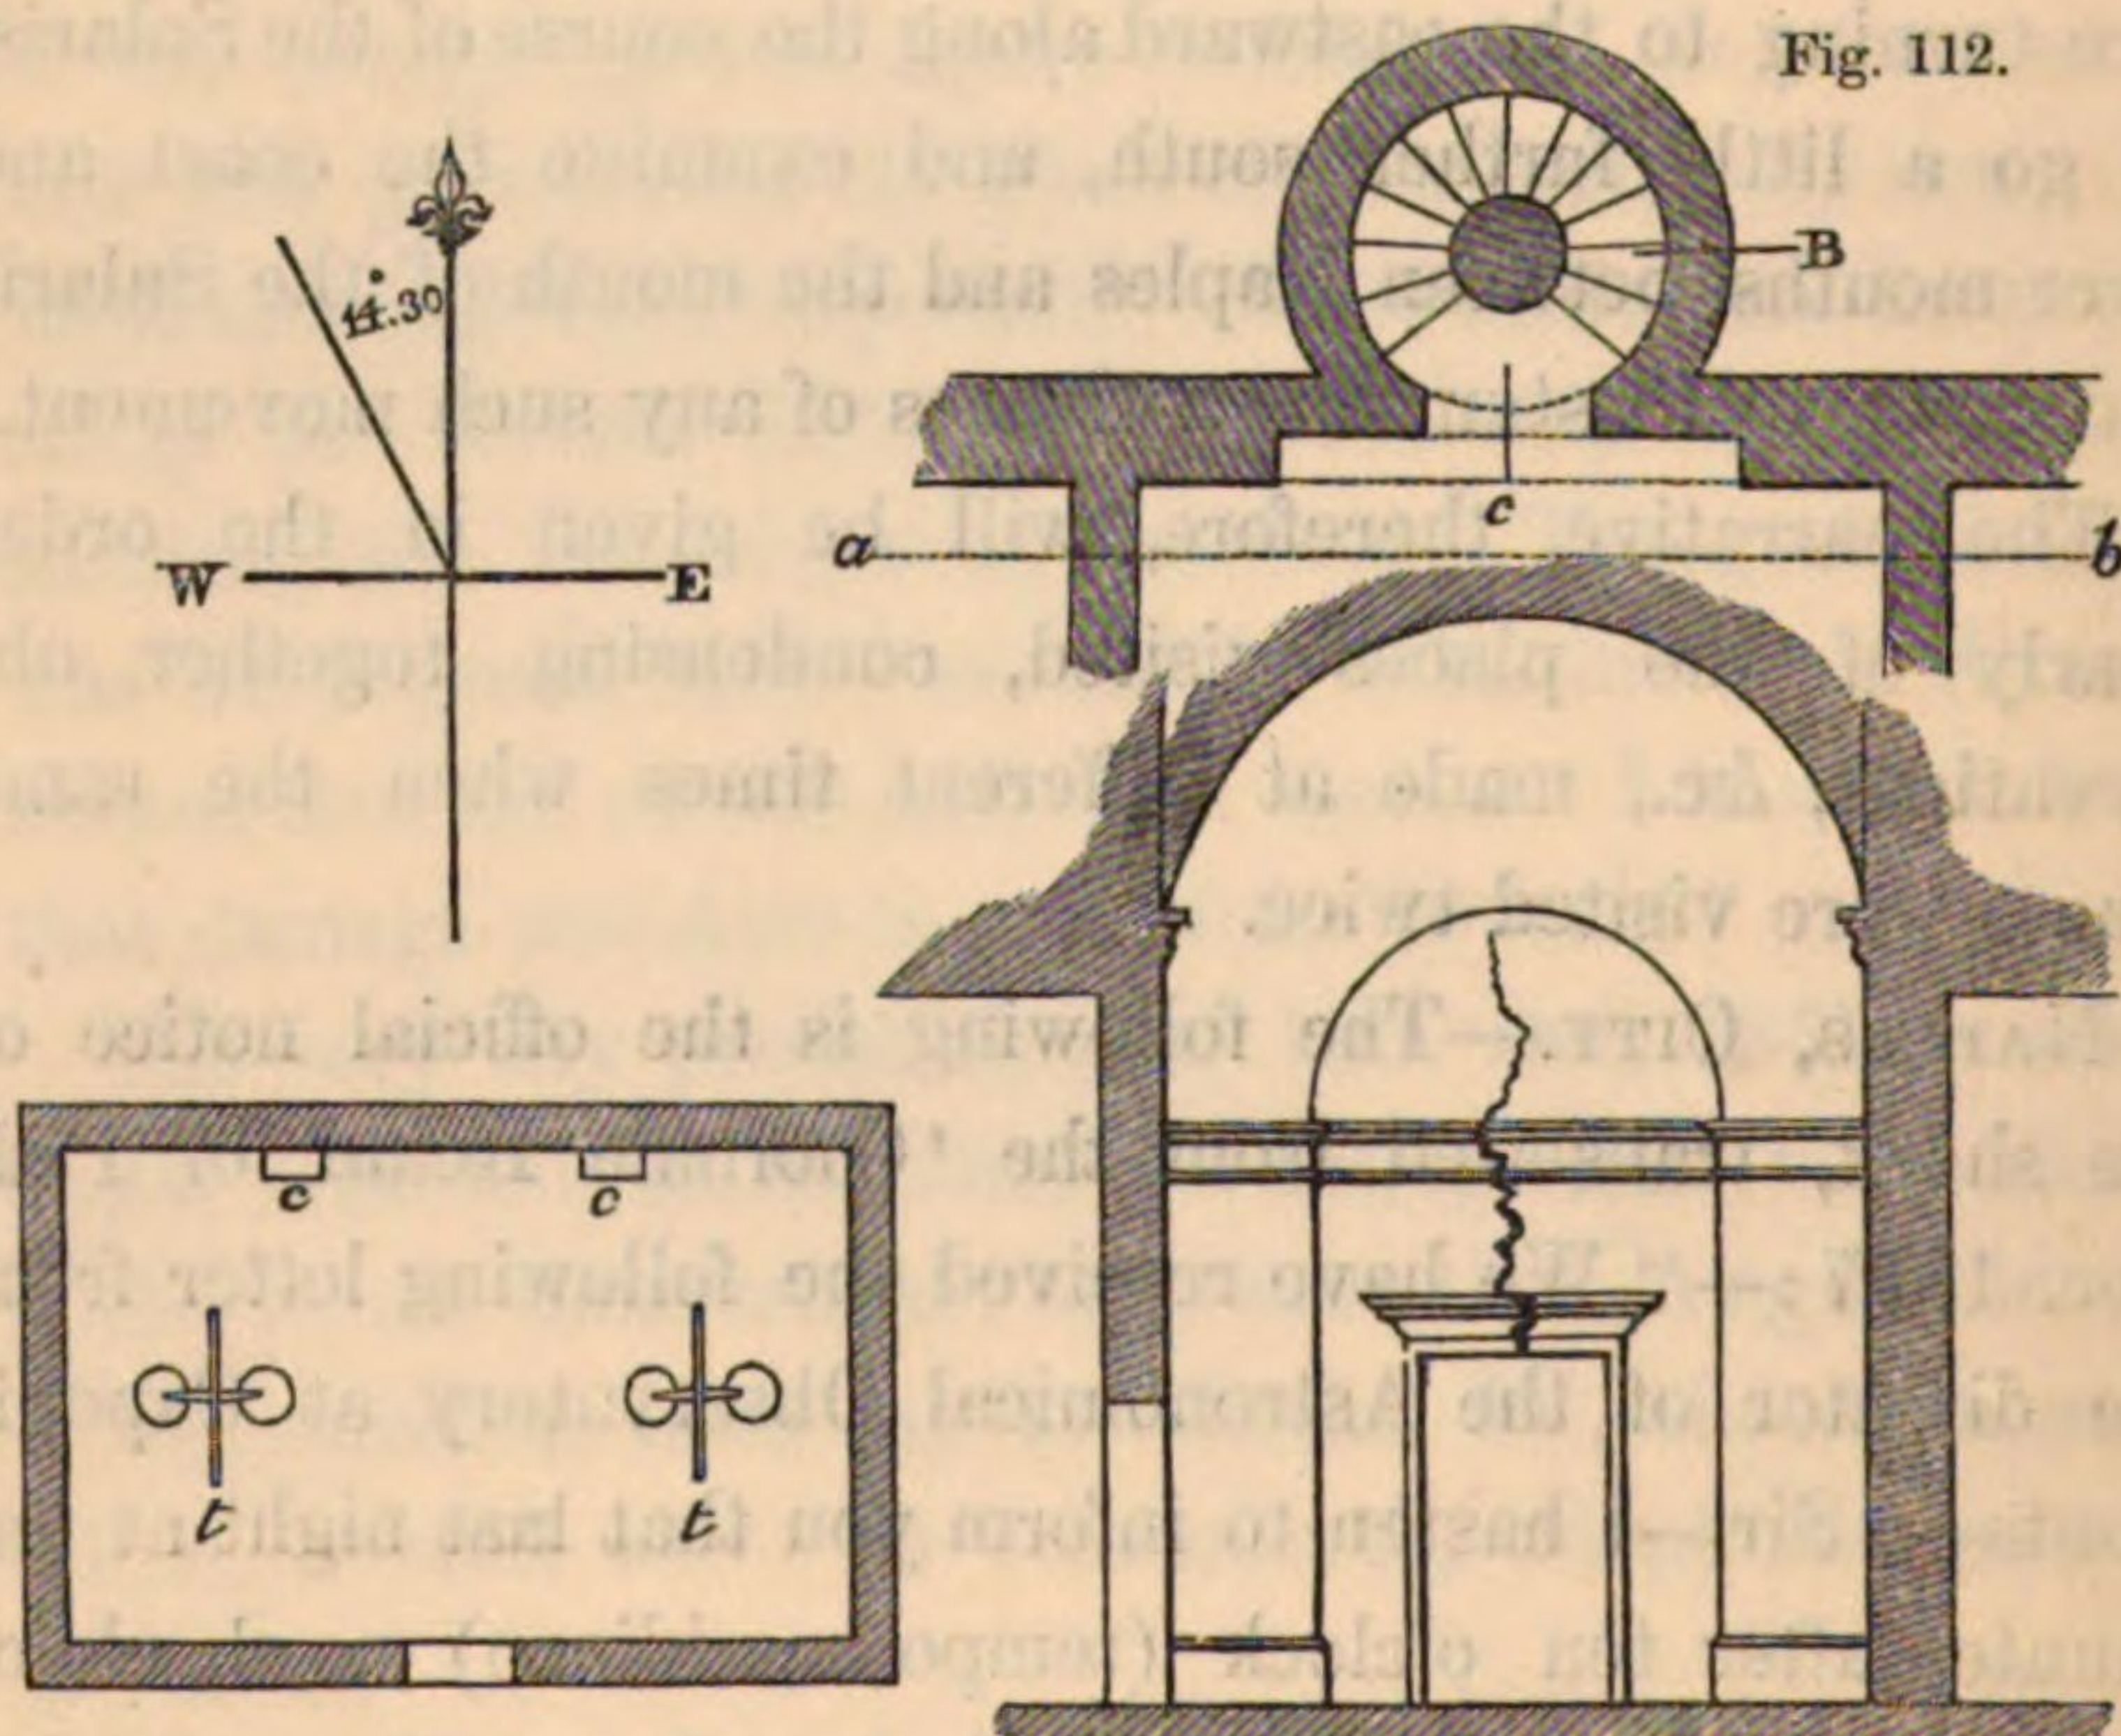
Fig. 111.

In the transit room (Fig. 111) (*t t* being the two

Fig. 113 is a section across the Salle Centrale at *a b* (Fig. 112), showing the interior elevation of the end next this tower. From the centre of the lintel of the doorway at *c*, a nearly vertical fissure, open 0.20 inch at bottom, extends upwards, becoming evanescent at about twelve feet, and its plane is in that of the meridian. Its continuation downwards can be traced from the centre of the sill of the doorway also.

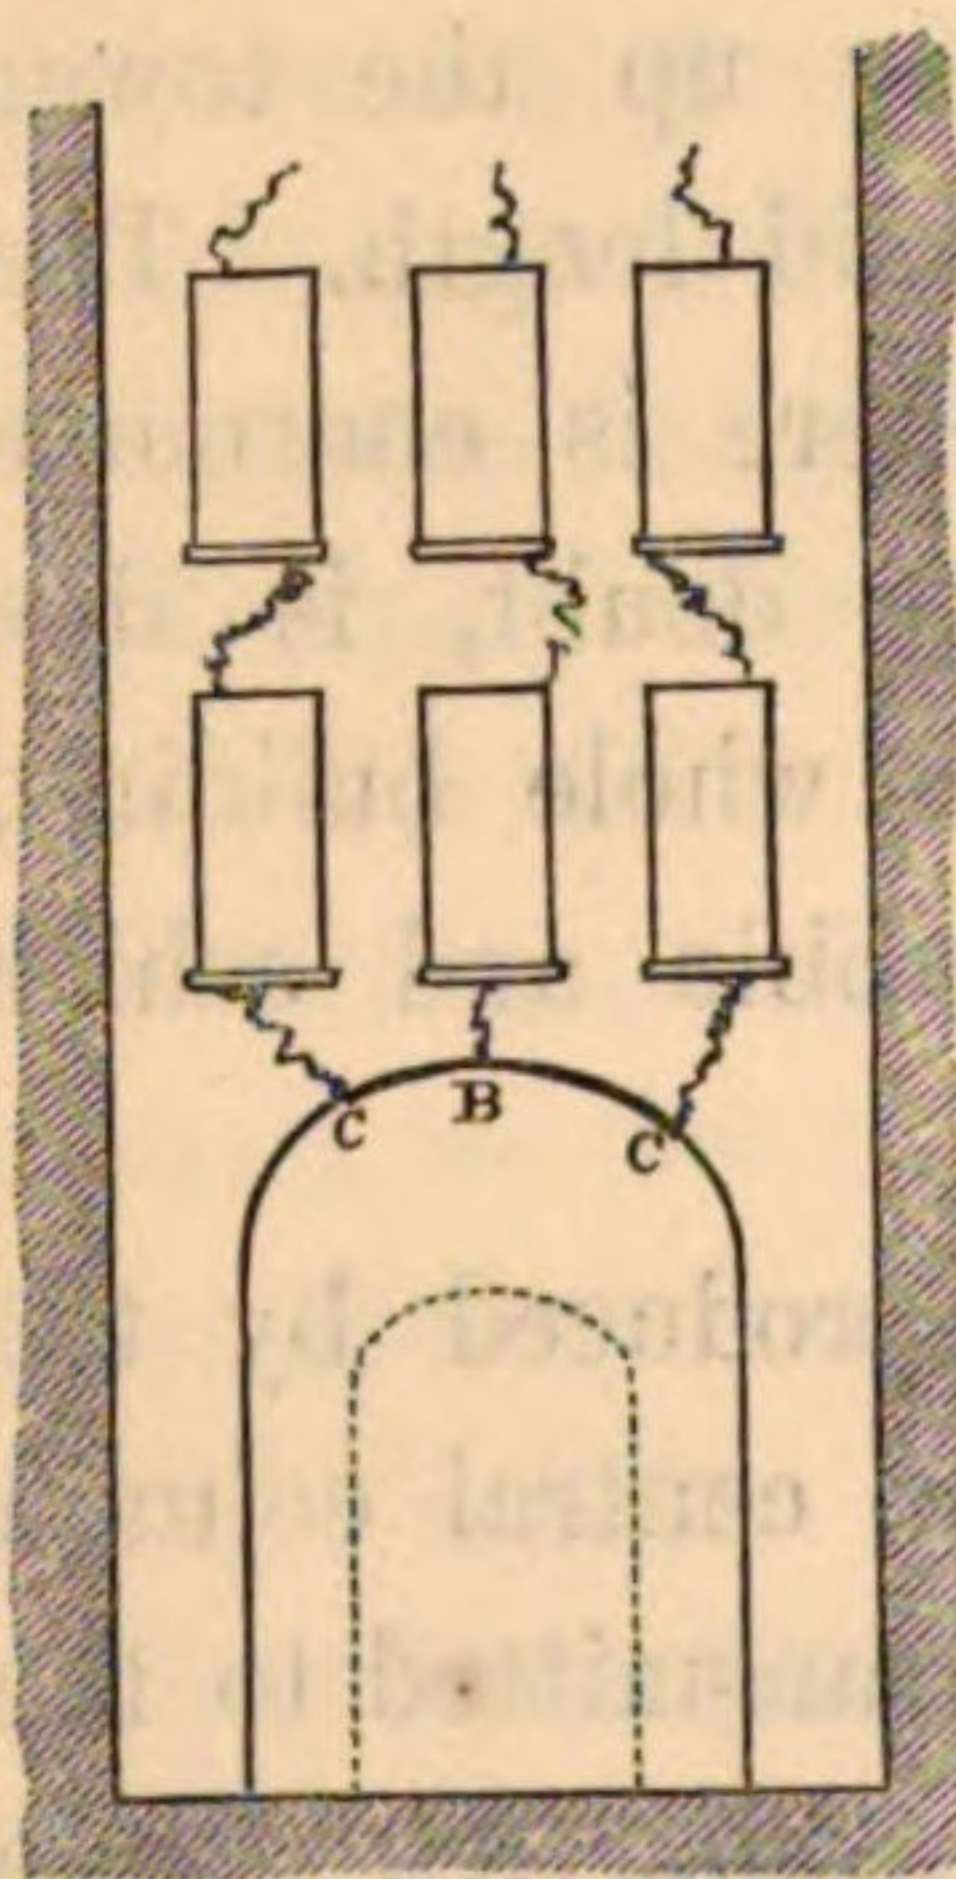
Fig. 14.

smaller arch as in dotted lines Fig. 114. The building, consisting of four lofty storeys, and nearly eighty feet in height, I found had been fissured from settlements for a

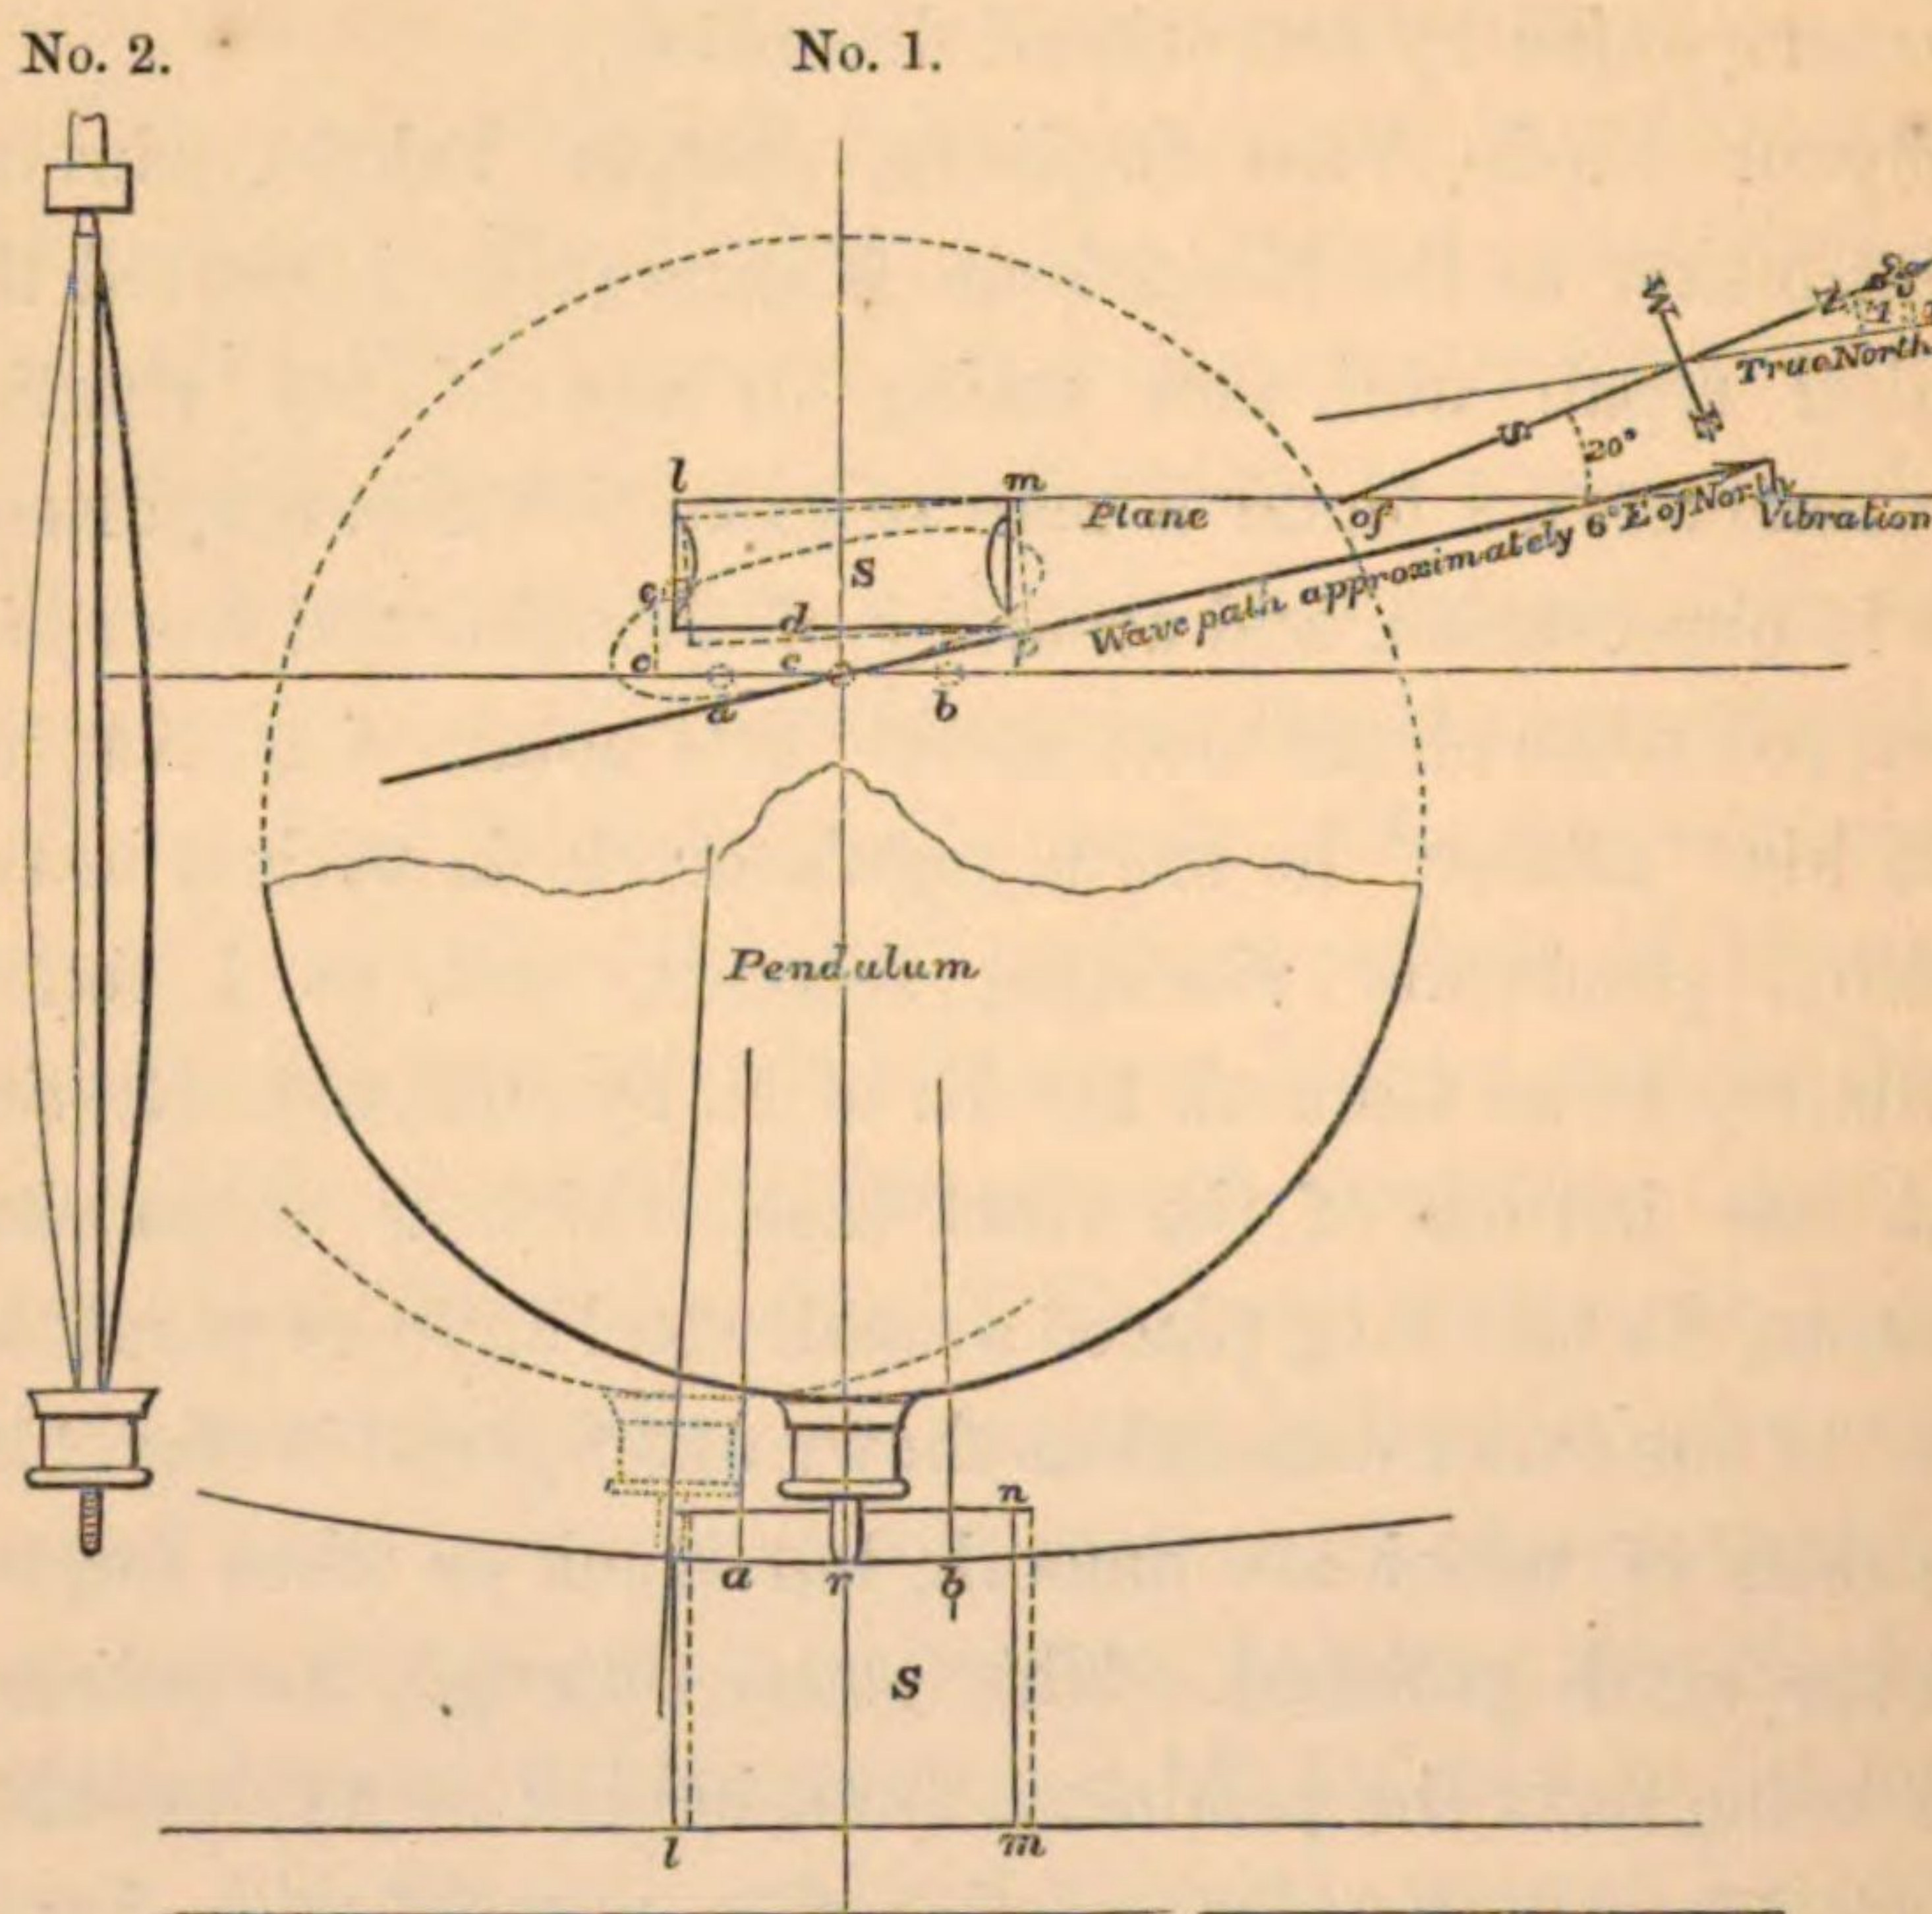
On the morning of the 17th December, 1857, Signor Fiodo found this clock stopped, and the screw of the pendulum in contact with the south end of the steel block,

which had been shifted from its place by the momentum of the pendulum, as in Fig. 115.

I shall recur to the inferences derivable from this in Part III. It is sufficient here to remark that the direction of wave movement indicated is one approximately 6° E. of N. The clock was going (*tempo meridiano*) or solar time for Naples, and was on the evening of the 16th December true to time within an error of 0.5 second. It had been stopped at $10^{\text{h}} 13' 26''$ P.M., which was therefore the time of the first shock at Naples, within less than half a second the error of the clock (slow), + the minute fraction of time due to the increased semi-arc of vibration.

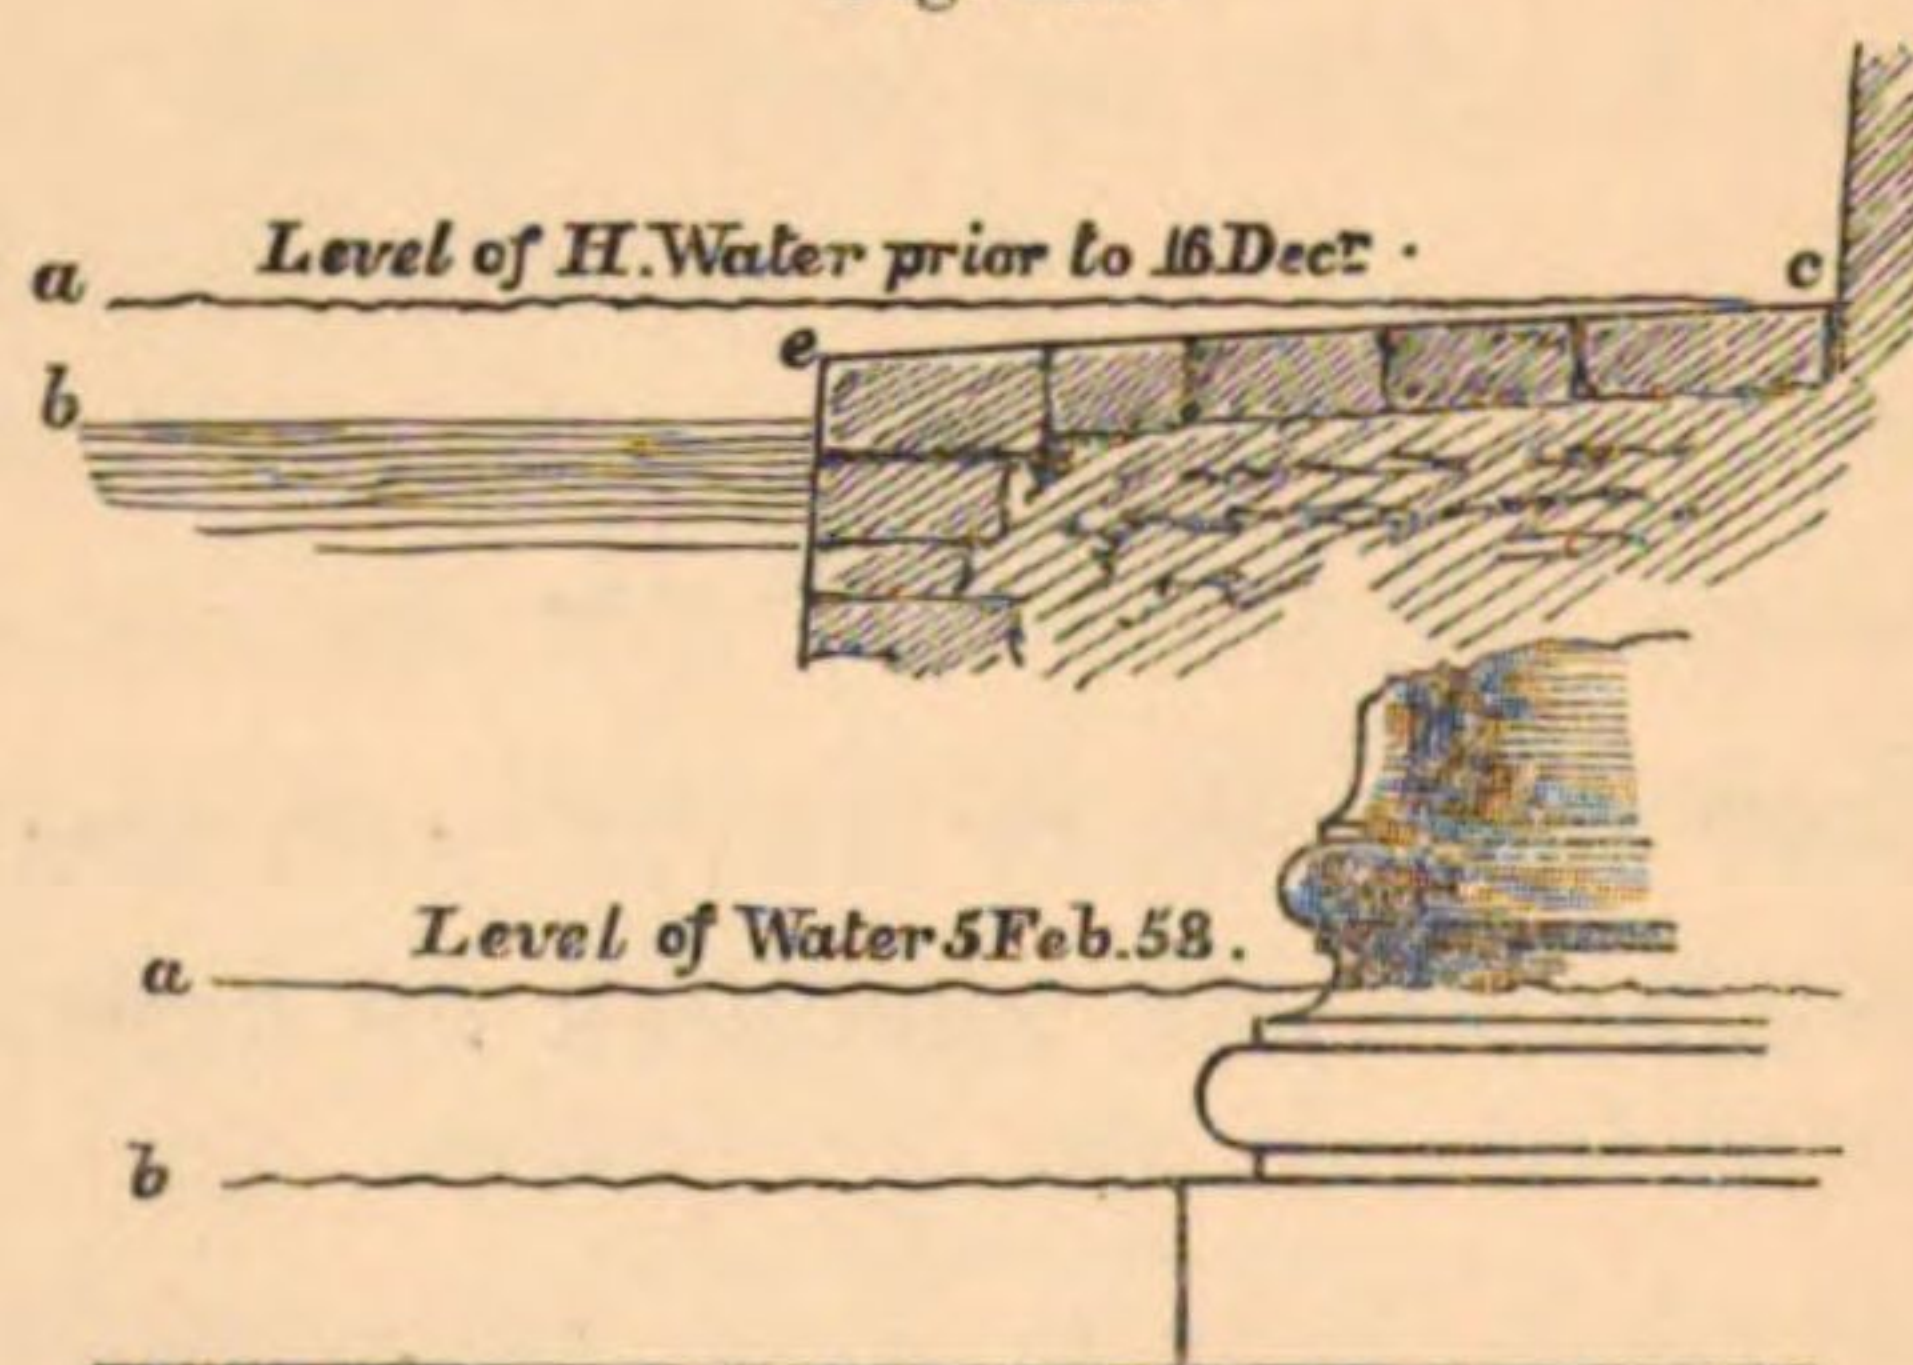
Fig. 117.

water which was then standing at *a* (Fig. 117), had, directly after the shock of December, fallen to *b*, equivalent to a rise of the temple of 7 inches, but that, since that time, the water had gradually returned to its former level, *i. e.* the land had sunk again.

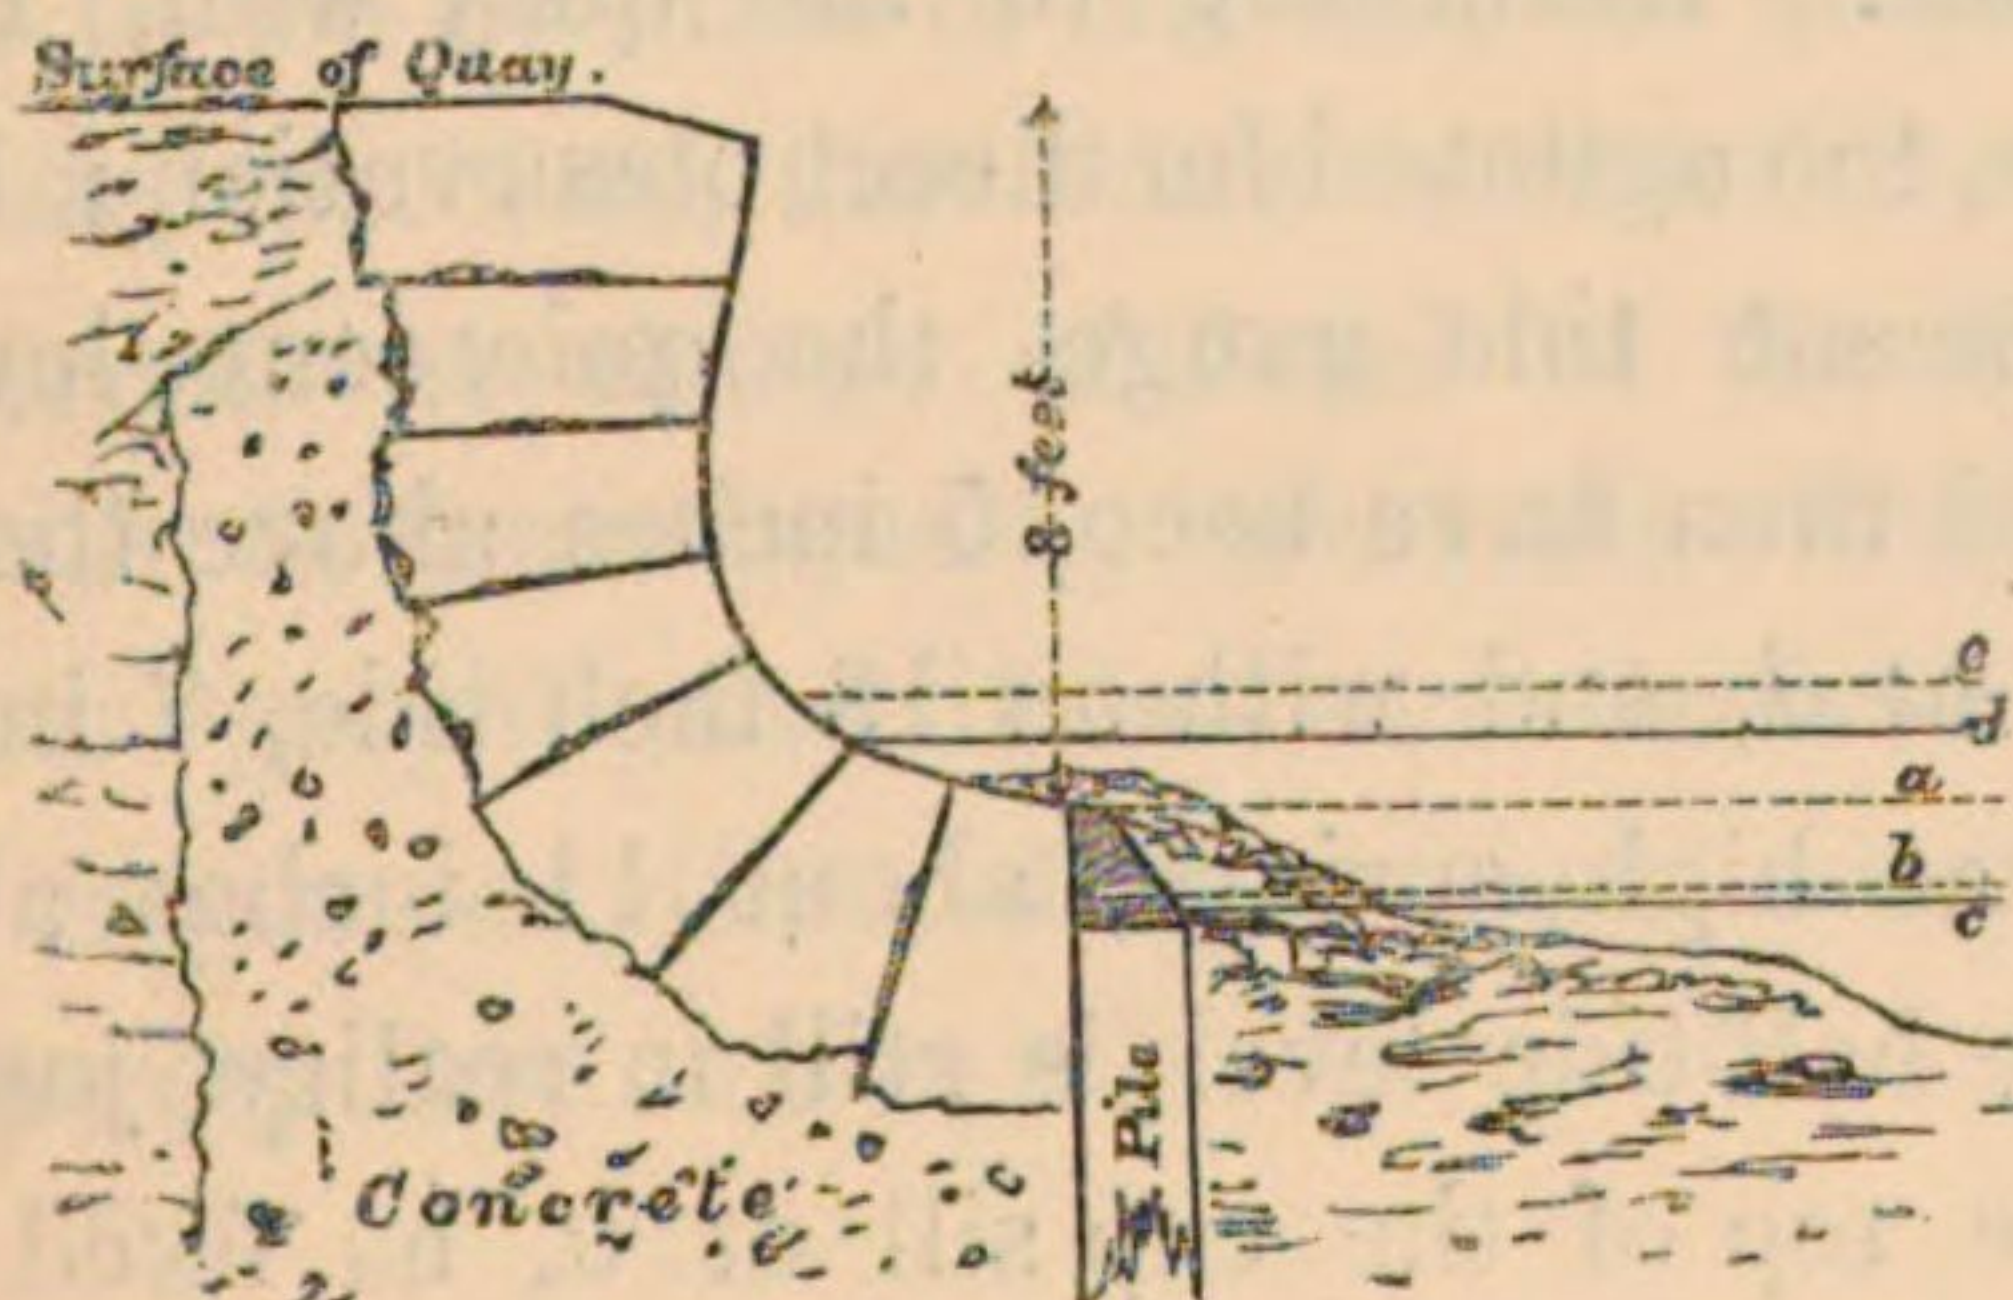
Fig. 118.

ON my way southwards, I received an introduction from the Intendente of Salerno, to Signor Palmieri, an engineer of the Ponte e Stradi, whom I fell in with at Eboli. In conversation he stated his opinion that since the shock of December 16th, the sea level all round the west coast, has been lower, *i. e.*, the land higher than before. He sustained this, by reference to a quay or wharf wall not very long since erected by himself at Amalfi on the shore of the Gulf of Salerno. The level of the sea at half

tide, he said, was always previously at *a* (Fig. 118), or coincident with the top of the timber work, at

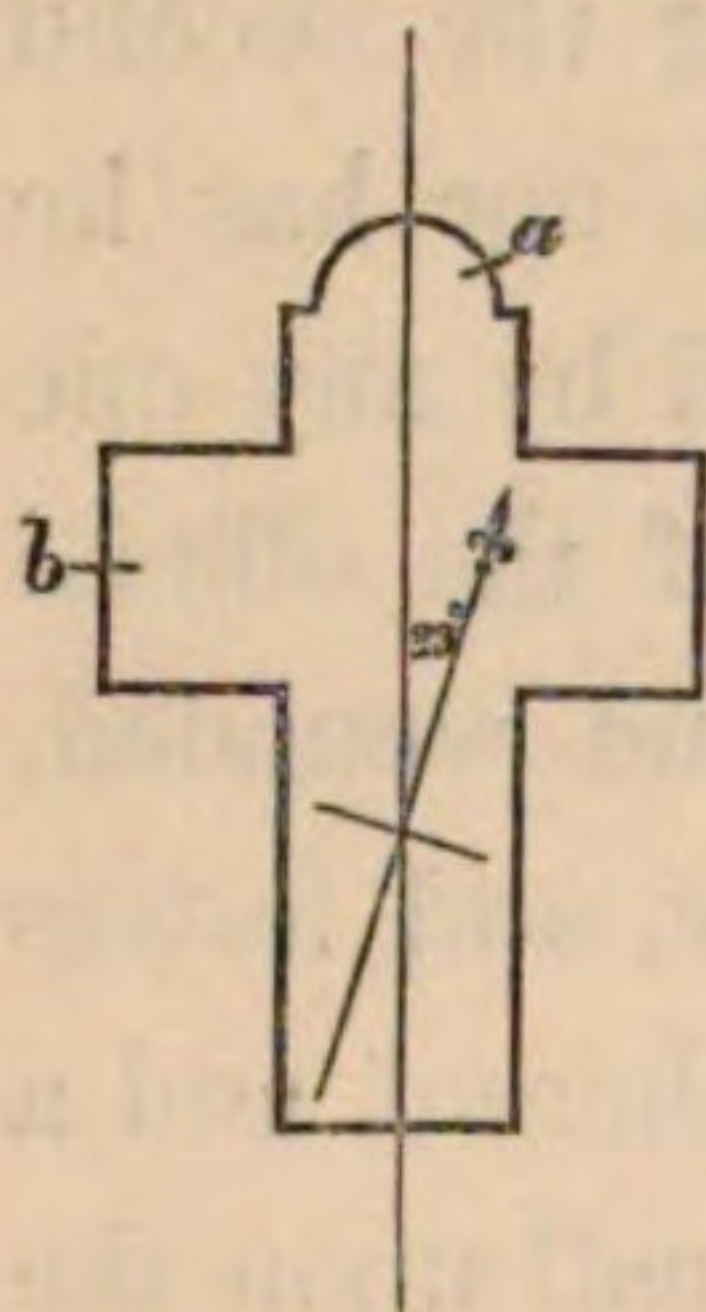
Fig. 121.

at *a*, Fig. 121, the other at *b*, in the western transept—both not far from vertical, and right down through window and door opes to the ground level, from the roof. These were originated, the Sacristan informed me, by small thread-like cracks (*filone*) in 1851, but were widened and lengthened now, in December 1857. *a* is now about 0.75 inch open near the top, and the roof of the apse has been sufficiently injured to require struts betwixt ceiling and floor. The dislocation of the

roof here, indicates a certain amount of emergence in the wave-path (but the fissures do not indicate any distinctly), 10° or 12° at most.

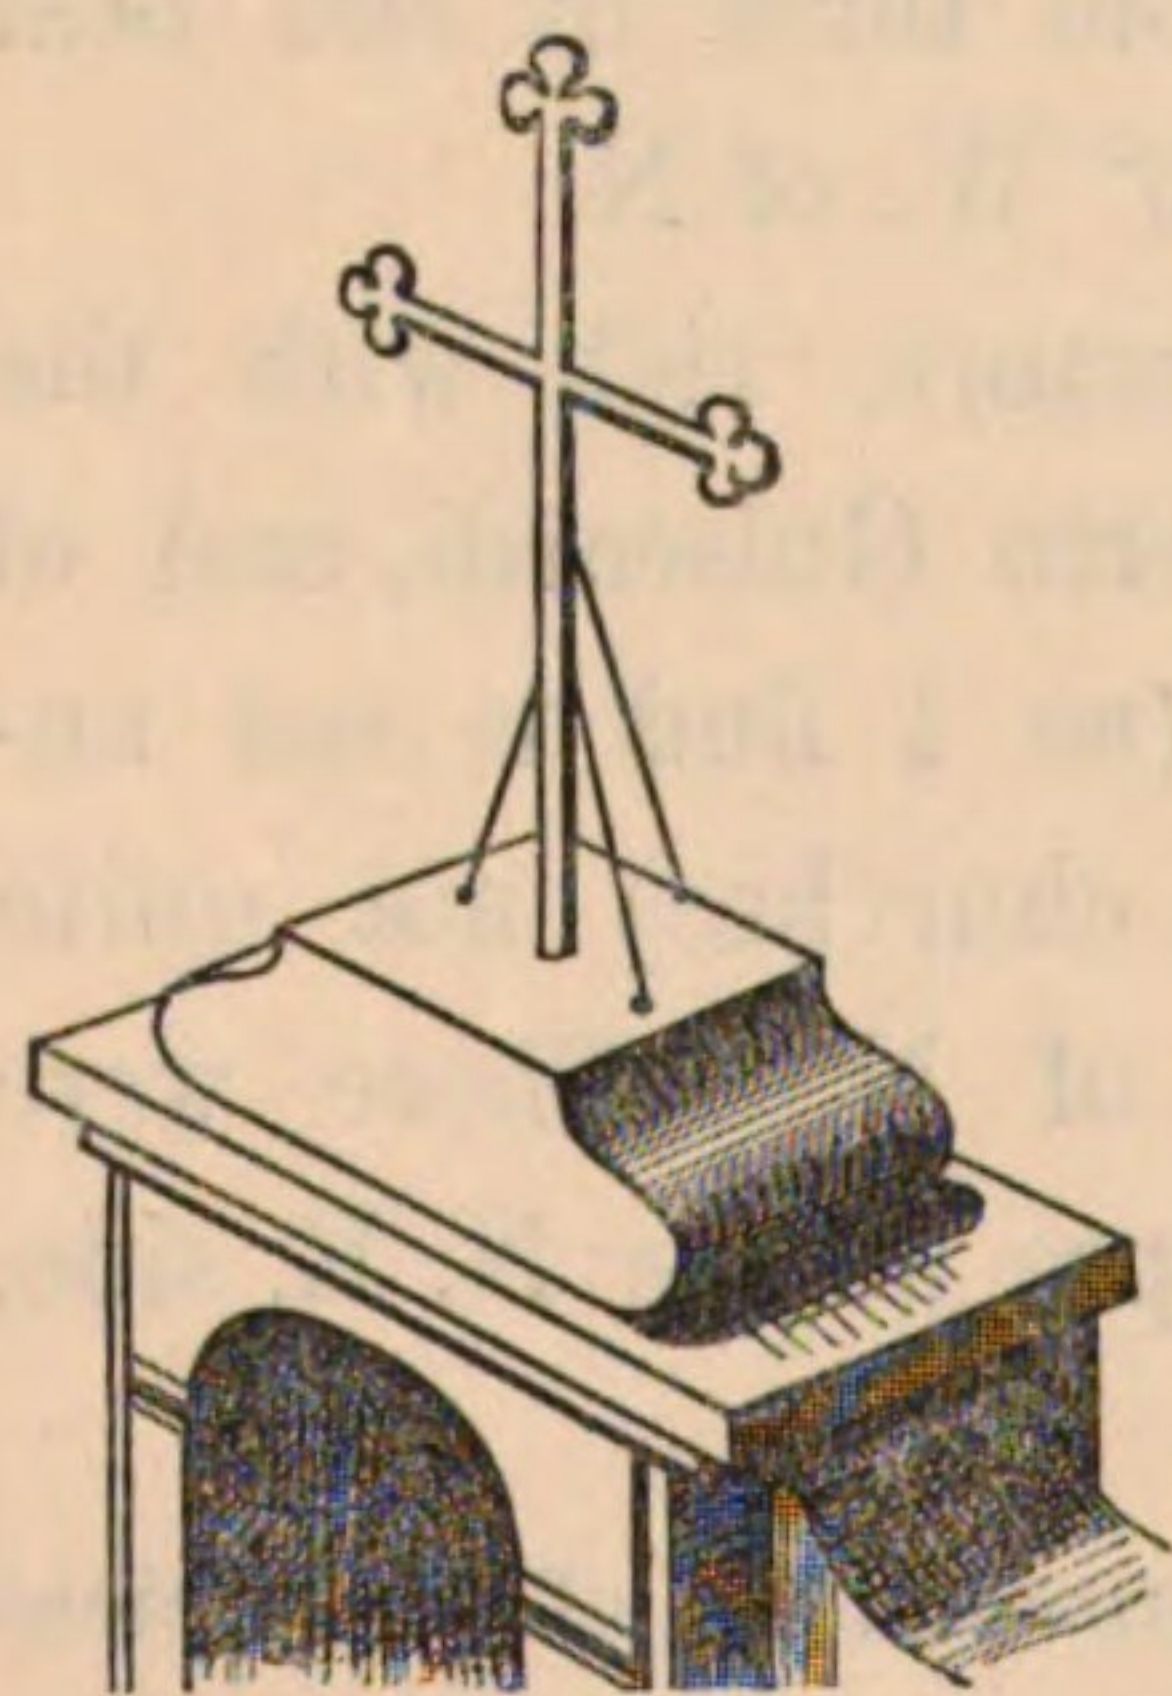
Fig. 122.

The direction I derive from them is $34^\circ 30'$ W. of N. There are upon various points of the cathedral and attached buildings many slender iron crosses, the iron flat bars of about $1\frac{1}{2}$ inch $\times$ $\frac{3}{8}$ inch thick, as in Fig. 122, none of

which present any signs of having been bent or twisted. They were all confined, however, by small diagonal stays of round iron, about $\frac{1}{4}$ inch diameter. In the noble old cloister court, a long stone, part of the shaft of an old column that had leaned against a wall running nearly N. and S., was overthrown, and indicated a wave-path of about 60° W. of N.
